Site Investigation, Remediation, and Reclamation of Oil & Gas and Brine Spills in North Dakota

Jacqueline Finck & Jonathan Ellingson

Terracon – West Fargo 860 9th Street NE Unit K West Fargo, ND 58078 Phone: (701) 282 9633 Fax: (701) 282 9635

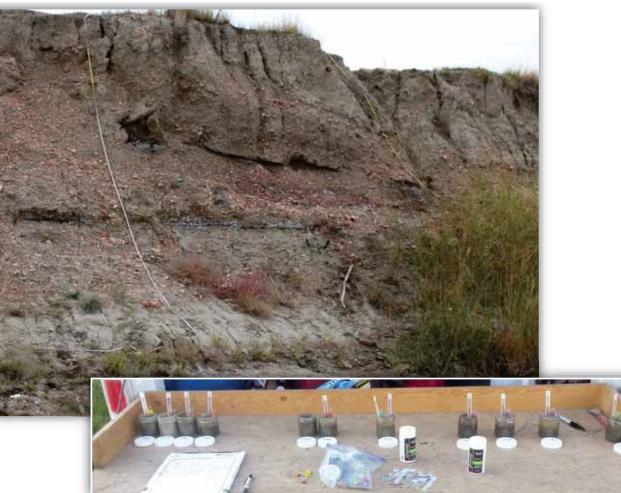
- EC meter equipped with stainless steel probe
- Measures a material's ability to conduct an electric current
- Microsiemens per centimeter (µS/cm)

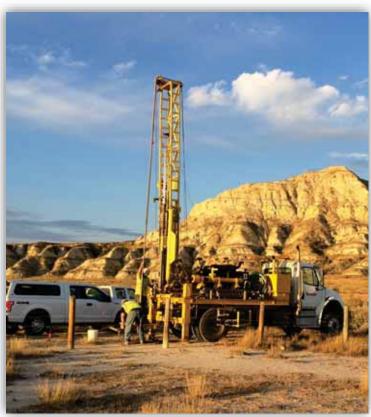
Drilling soil boring to collect soil samples and install temporary groundwater monitoring well.

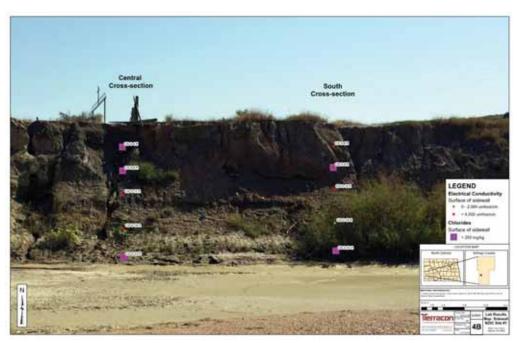
Laboratory results at the surface of the sidewall.

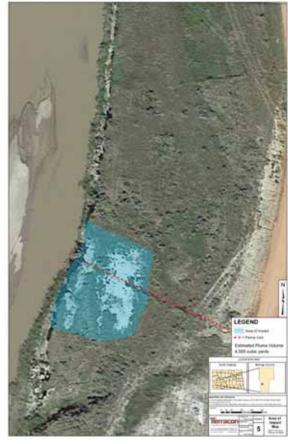
Approximate area of impact anticipated from field and lab results.

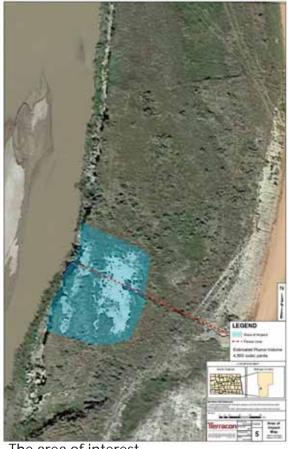
The area of interest outlined by flags.

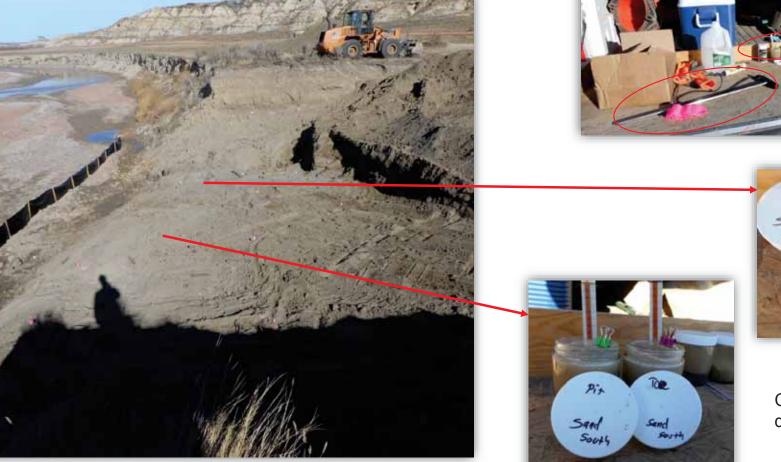
Continuous field screening during excavation.

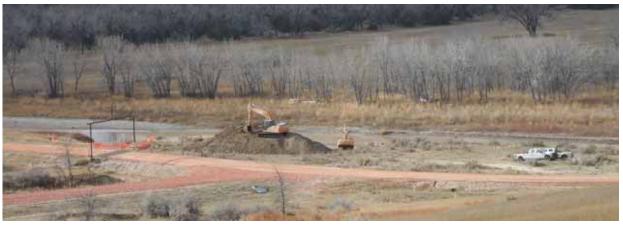
View at the excavation of the historical pit.

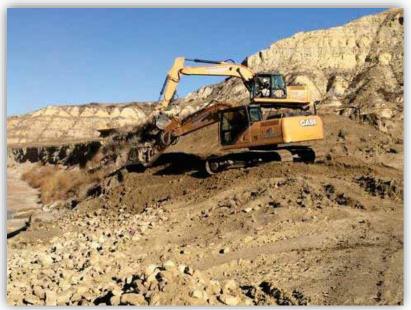
Placing rip-rap along excavated area.

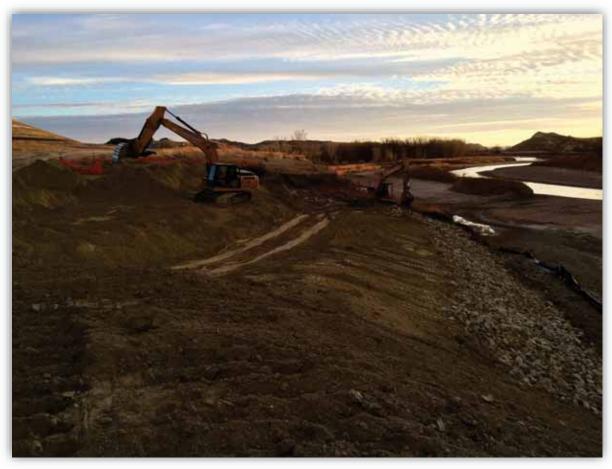
Backfilling with clay material and placing rip-rap along excavated area.

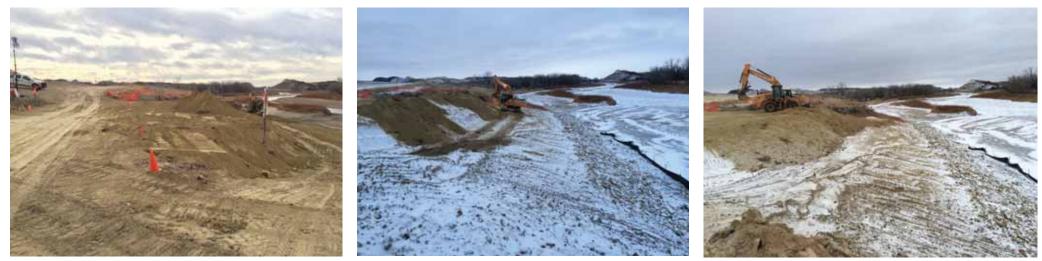
Backfilling with clay material with rip-rap placement along excavated area.

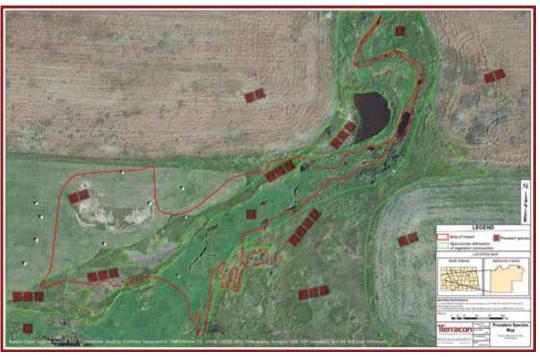
A study was completed to analyze what prevalent species of plants were growing at this specific site.

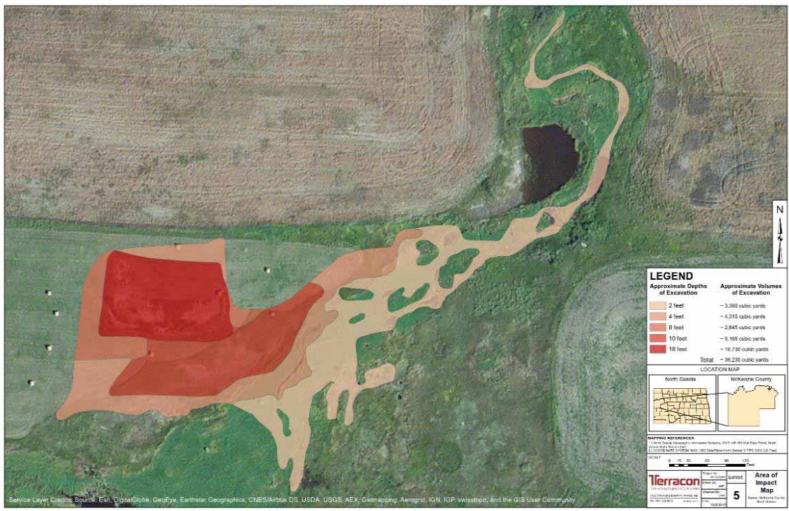
Approximate area of impact anticipated from field and lab results.

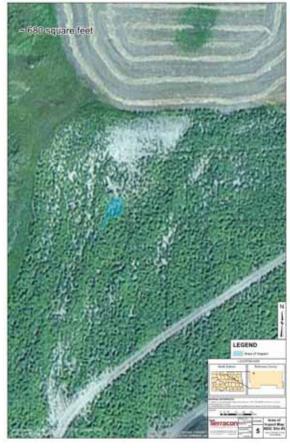
Approximate area of impact from site assessment (visual).

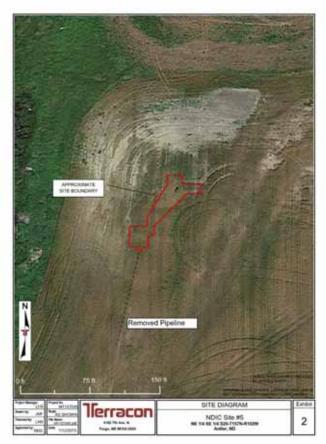
Site Diagram showing excavated area and the piping that was removed.

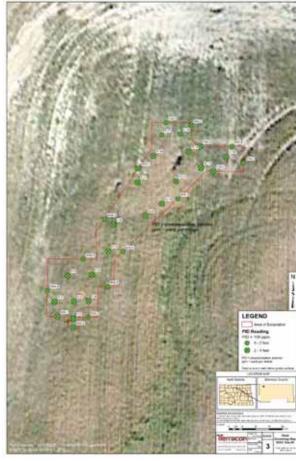
Field screening map.

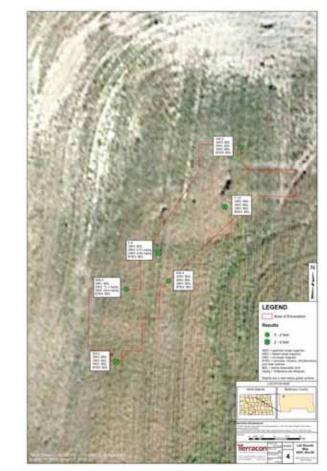
Lab results map.
